## **Water for Nature Environmental Watering Site Monitoring Report** by Dr Anne Jensen

### **Lyrup Lagoon, Gurra Gurra wetlands complex, South Australian Riverland** July 2013 to June 2016

<b>Water For Nature Environmental Watering Site Monitoring Report</b>	
<b>Site name</b>	Lyrup Lagoon, Gurra Gurra wetlands complex, South Australian Riverland
<b>Reporting period</b>	July 2013 to June 2016
<b>Date prepared</b>	July 2016
<b>Location</b>

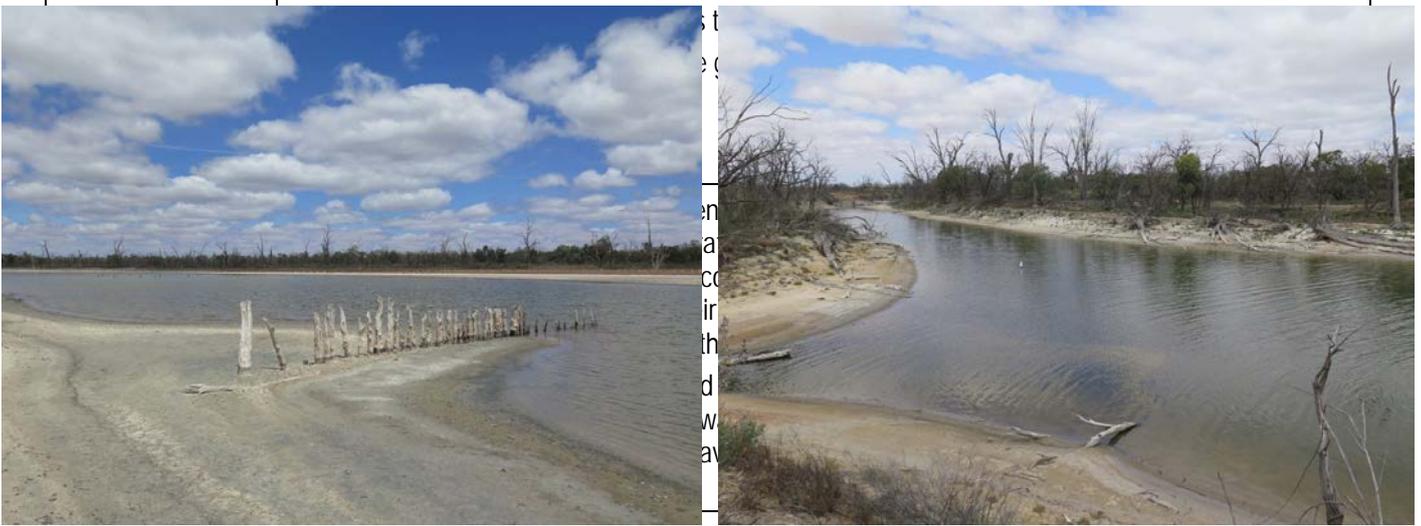
Figure 1 Lyrup Lagoon. showing main pool (top left), and downstream channel (right) (Photos: Anne Jensen)

<b>History 2013-16</b>	This raised water levels in the lagoon significantly but was still below river pool level, and the water did not flow through Tortoise Crossing.
<b>Habitat</b>	Lyrup Lagoon provides a permanent pool of mostly saline to hyper-saline water, fed by regional groundwater as a result of local irrigation, occasionally freshened when river flows exceed 35,000 ML/d. It is used regularly by waterbird species associated with saline aquatic ecosystems, including Avocets and Black-winged Stilts. The muddy shores provide food sources for waders and shorebirds, and the adjacent floodplain has dense regeneration of black box seedlings following inundation by the 2011 flood peak. The lagoon was formerly bordered by river red gums but these are long dead due to lack of freshwater flows. A line of healthy black box and dryland tea-tree border the lagoon adjacent to irrigation blocks, supported by irrigation drainage water.

<b>Future Watering</b>	Repeat seasonal fillings in late spring, taking into account natural flood events, with particular monitoring to detect presence of live brine shrimp or cysts; maximise filling of Lyrup Lagoon to at least pool level, subject to monitoring of salinity of any water discharging through Tortoise Crossing into the top end of Gurra Lakes

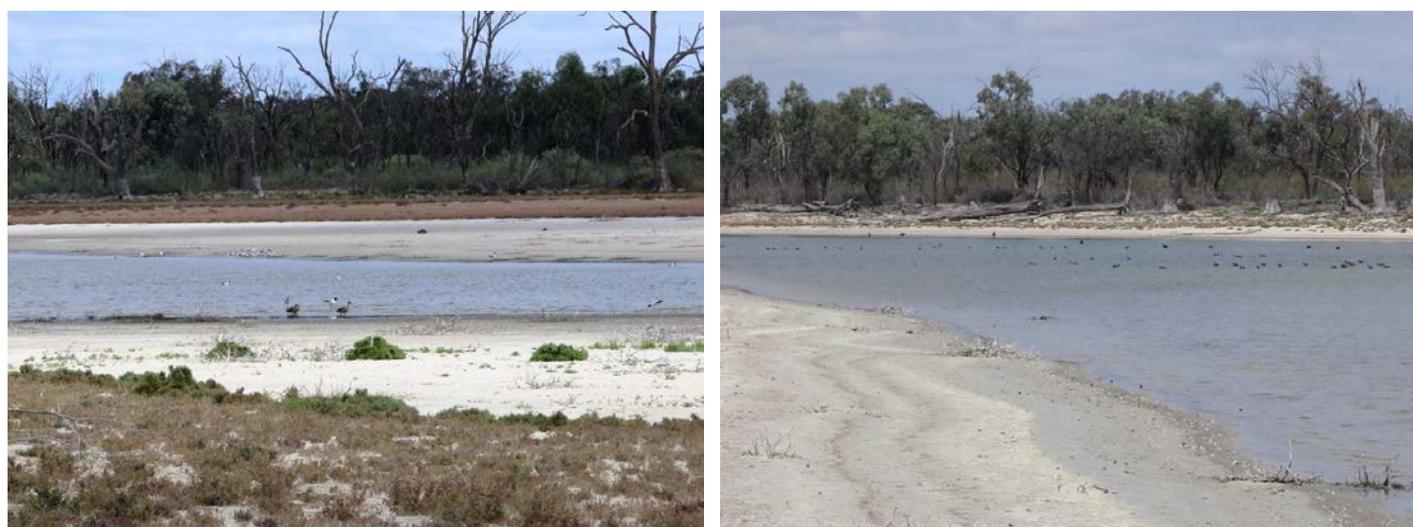
<b>Annual Observations</b> <i>(including species of conservation significance (state or Commonwealth listed threatened species, or listed migratory species) observed at the site, any breeding of frogs, birds or other prominent species observed at the site and details of any observable responses in vegetation, such as improved vigour or significant new growth)</i>	<b>2013-14</b> N/A
	<b>2014-15</b> N/A
	<b>2015-16</b> (observations by consultant Elizabeth Lescheid) Limited conclusions can be drawn from three surveys, due to the mobility of birds, changing daily conditions and availability of alternative habitats in the vicinity. Watering increased food sources and increased numbers of waterfowl were noted. This response was possibly due to reduced salinities, but also may have been use of the location as a refuge from hunting. Vulnerable species Freckled Duck, Black-winged Stilt and Straw-necked Ibis were observed during monitoring. Rare species observed included Red-kneed Dotterel, Australasian Shoveler, Black-fronted Dotterel and Caspian Tern. Breeding was noted in vulnerable Black-winged stilt, Rare Black-fronted Dotterel and Near-Threatened Black-faced Cuckoo-Shrike and Pied Butcherbird. Avocets, Stilts and Pink-eared Ducks were recorded, which can indicate more saline conditions and salt-tolerant food sources. No brine shrimp were observed, but these could have been missed due to the timing of monitoring surveys. It is also possible that higher water levels (above pool level) are required to trigger brine shrimp emergence. Some recommendations have been made to investigate this aspect further, to try to determine the water regime required to trigger a bloom of brine shrimp.

**Figure 2** Lyrup Lagoon. showing waterbirds and regeneration on the floodplain (below) in October 2014 (Photos: Anne Jensen)
